TECHNICAL REPORT REMR-CS-16

REPAIR OF DAM INTAKE STRUCTURES AND CONDUITS. CASE HISTORIES

Roy L. Campbell, Sr., Dennis L. Bean

January 1988

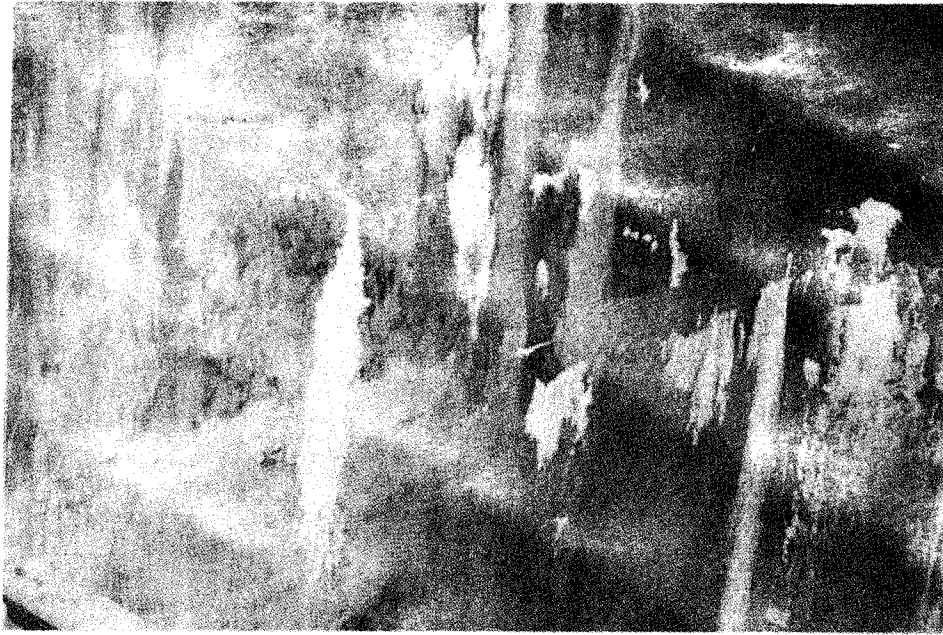
Figure 12. Area of interior wall treated with Vandex, Beltzville Dam, June 1983

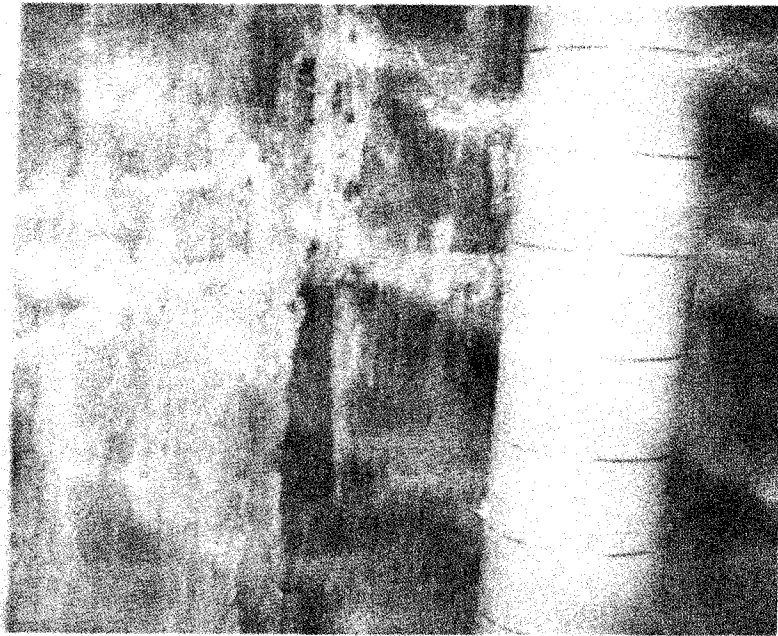
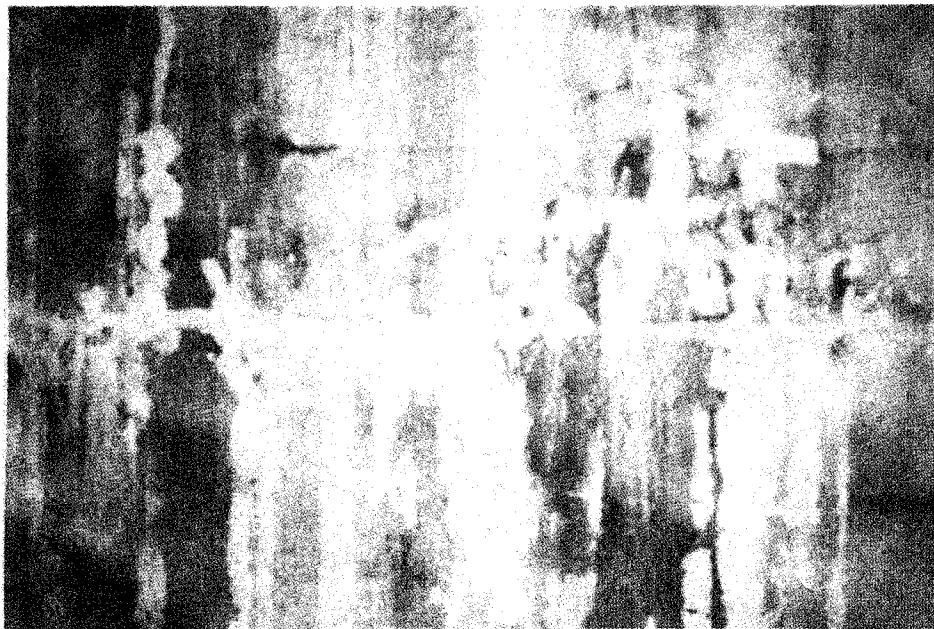
a) West wall, elevation 612 ft

b) North wall, elevation 600 ft

Figure 13. Areas repaired with Sikadur 52
Injection Resin, Beltzville Dam, January 1985

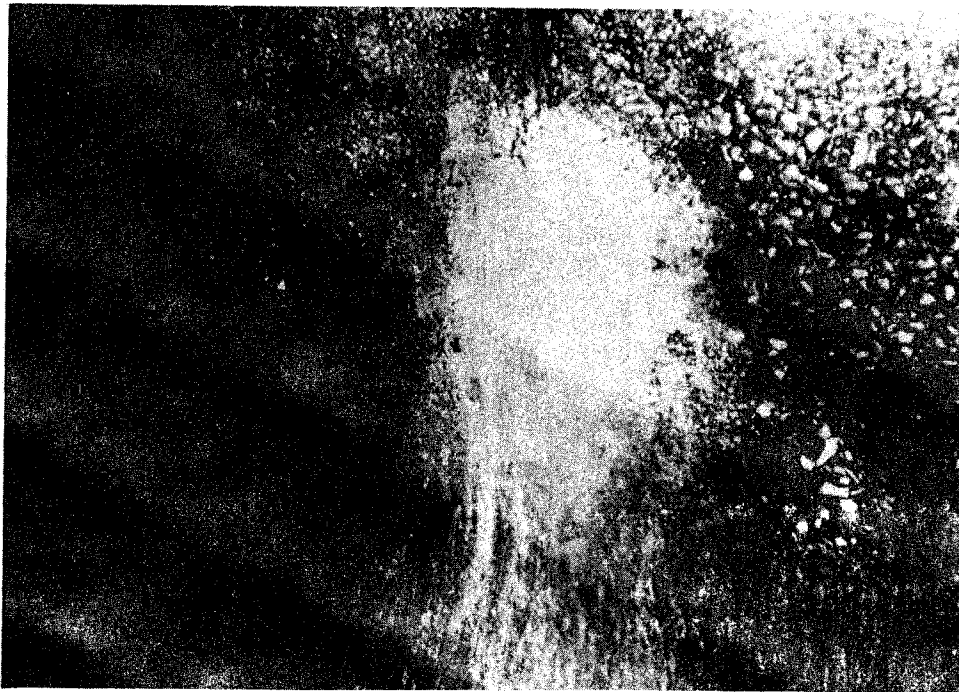
Figure 25. Surface after repair, Buckhorn Lake Dam, August 1986

99. After the Preco Plug had set for about 20 min, 2-1/2 gal of TACSS-020 NF was mixed with 5 percent of C-852 accelerator. With the other four valves closed, grout was pumped through the open valve of the port occupying the nondrilled hole (Figure 24). There were a number of small seeps that existed prior to the start of the grouting operation. After 2 to 3 min of pumping these seeps stopped with grout solidifying on the interior wall at some of the seep locations. After all of the approximately 2-1/2 gal of grout had been pumped, the port valve was closed to allow time for grout to react and solidify. Another 2-1/2 gal of grout was prepared and the pump connected to the single port downstream of the joint. The pumping of grout into the port was initiated, but no grout was taken. With valves closed and hose removed, the previously injected grout was allowed to gel for an additional 30 min. Ports were then cut off slightly below the wall surface and projecting oakum removed. Preco Plug was mixed and spread over the work area to form a protective seal (Figure 25).

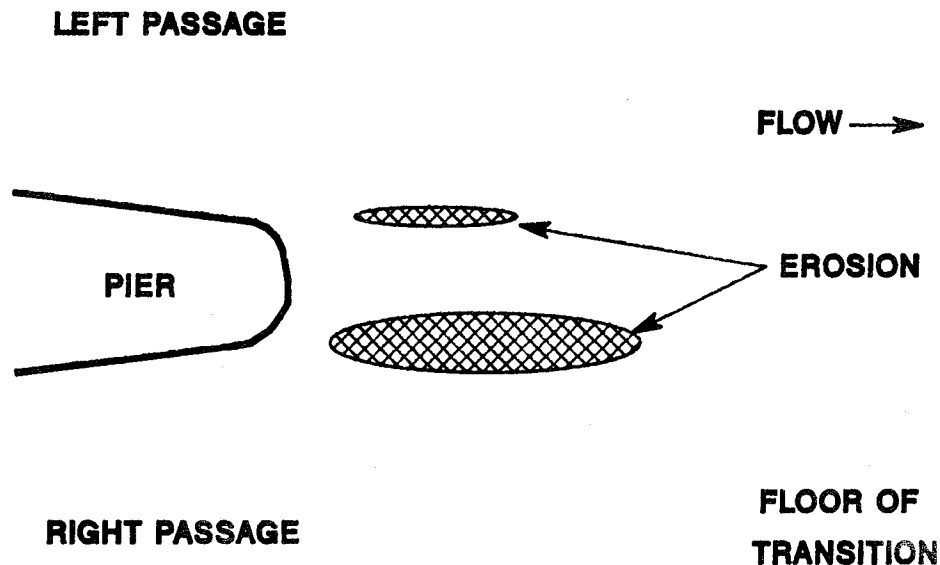
Figure 28. Sketch of abrasion damage in floor of transition, Cave Run Dam, 1982

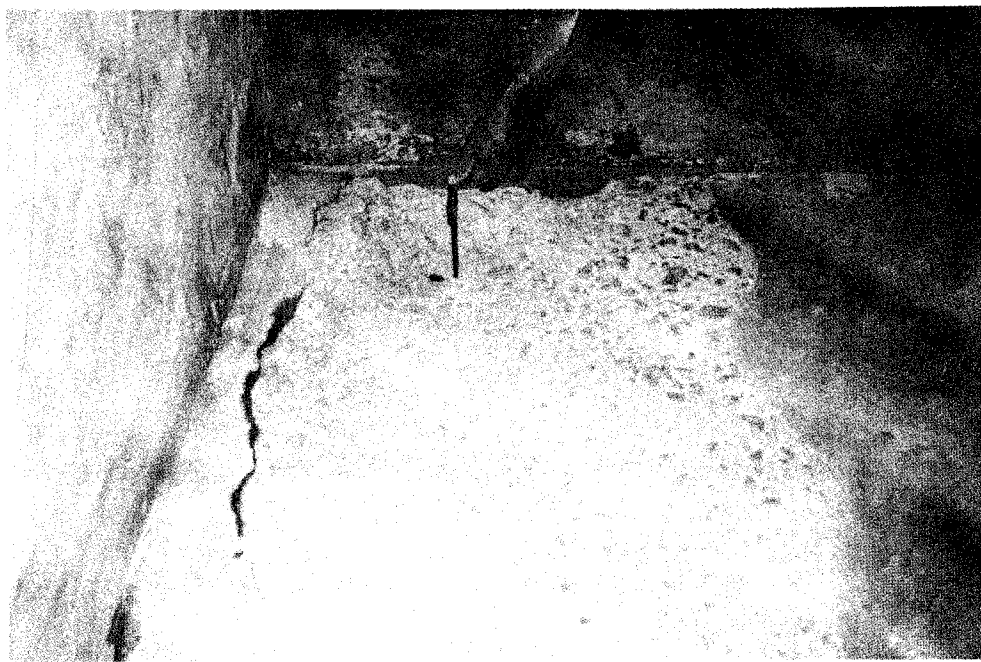
157. A delaminated section of the invert repair was pried loose and examined. The Quartz was firmly attached to the concrete indicating the bond was good and that the concrete beneath the bond had failed. It was speculated that seepage at the joint during the repair had reduced the bond causing the Magma Quartz at the joint to spall, thereby, setting up an abrupt surface irregularity for cavitation to occur. Water then progressively undermined the Magma

Figure 40. Erosion damage, Isabella Dam, December 1983

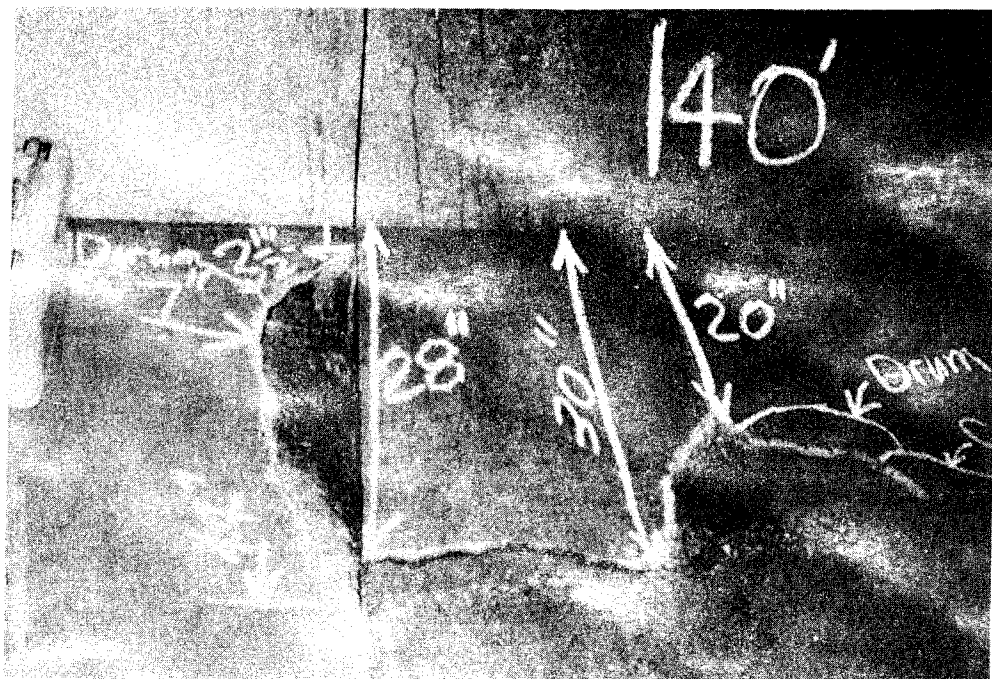
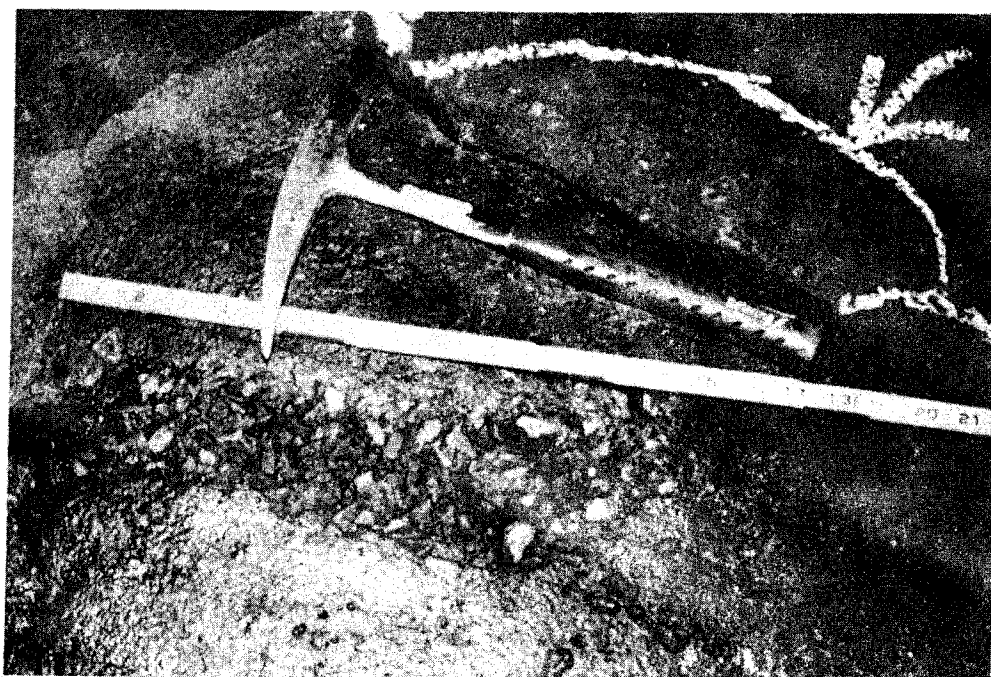
a. Downstream end of passage

b. Closeup

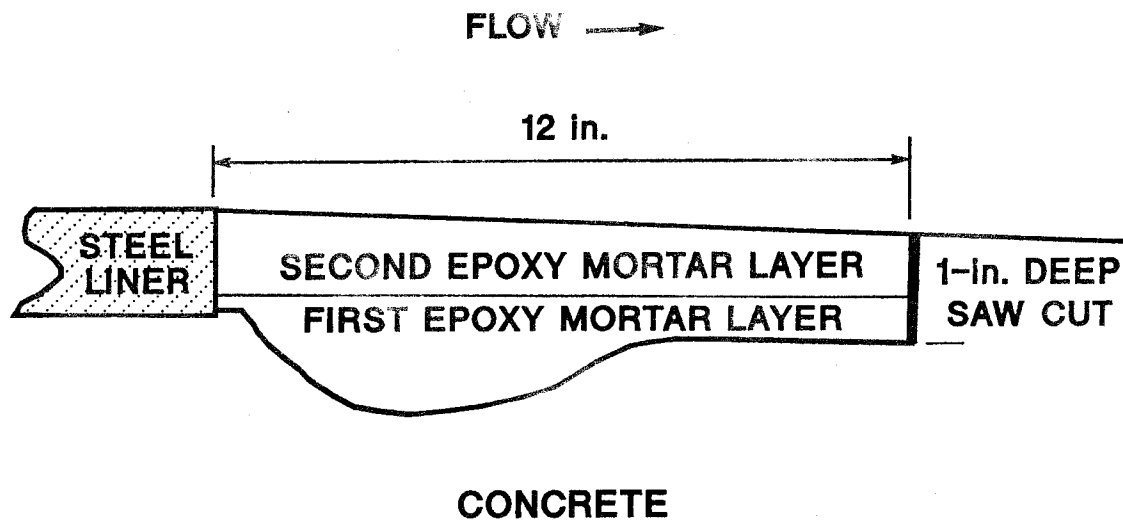
196. In May 1985, 21 months later, the patch was inspected. The epoxy mortar surface had settled or flowed, before hardening, to about 1/4 to 3/8 in. below the level of the steel. It appeared that the bond was still intact and that the mortar surface had little sign of wear.

Figure 45. Repair immediately downstream of steel liner, Milford Dam

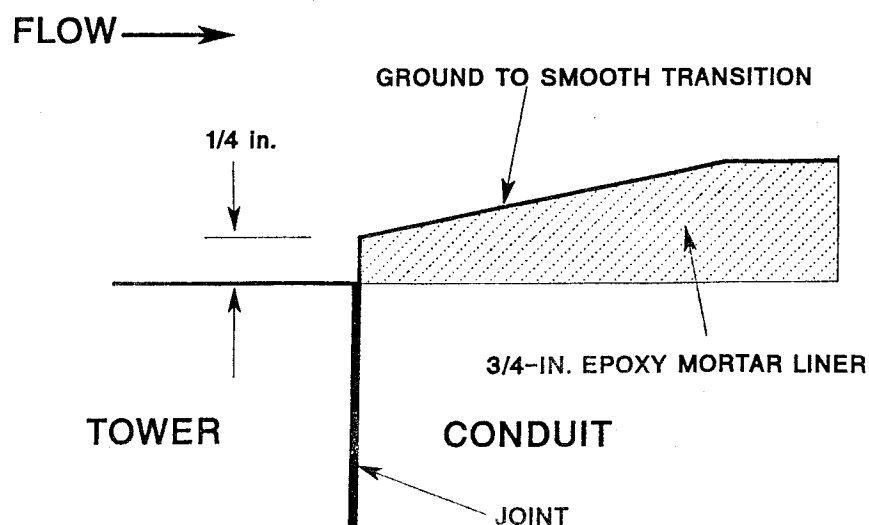
Figure 46. Edge ground to provide smooth transition at monolith joint, Milford Dam

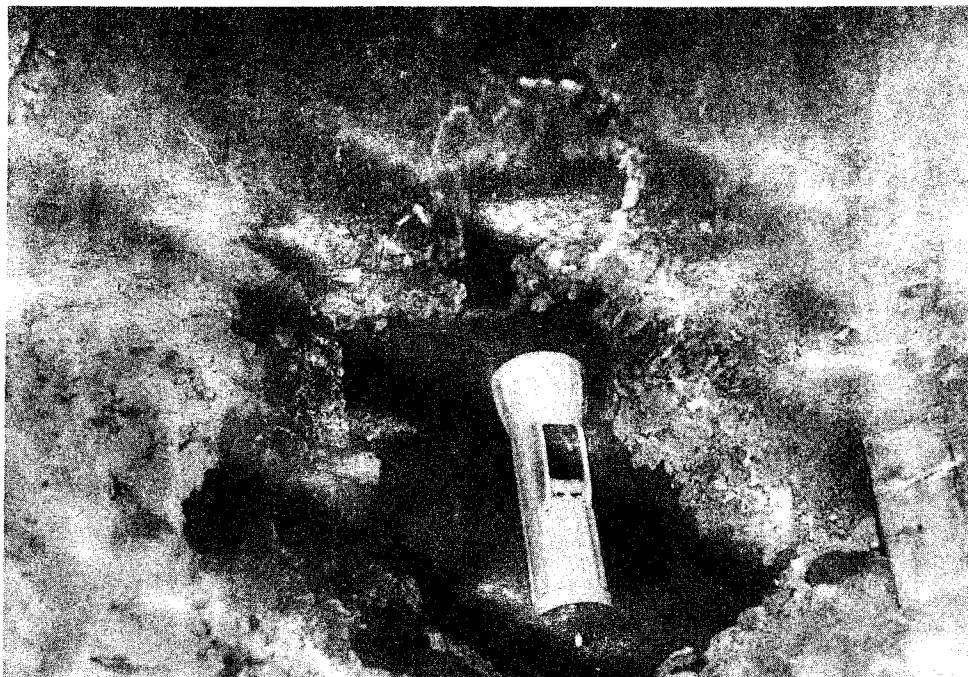
199. The metal forms that were used during placement were removed from the interior of the conduit for the first time in 1984. About two-thirds of the way up the conduit there was a 60 to 80-ft reach of honeycomb areas and cavities along the invert. In one spot there was a triangular shaped cavity partly covered with a piece of metal plate. The cavity extended through the full depth of the slab and appeared to be wider at the bottom. At another monolith upstream, there were two cavities that penetrated the full depth of slab. One cavity in the middle of the monolith (Figure 47) was about 6 ft long with a varying width of about 10 in. at the maximum. The second cavity located at the upstream end of this monolith was about 12 in. wide by 18 in. long. At the joint, the water stop was firmly embedded into the adjacent monolith, but fully exposed on the side of the cavity. There were two or three other V shaped cavities 5 to 7 ft long and varying in depth from about 1-1/2 to 8 in. About two-fifths of the way up the conduit, the end of a 3- by 3-in. piece of wood was embedded about 8 in. left of invert. Except for an area of scattered pits (approximately 1-1/2 in. in diameter by 1/2 in. deep)

Figure 47. Hole through conduit at invert, Mulberry Dam
